Stewart Dew Point Hickory, PA

A-Scan Baseline Inspection

Tank No.: T-685

Tank Name: Lube Oil/Drain Tank

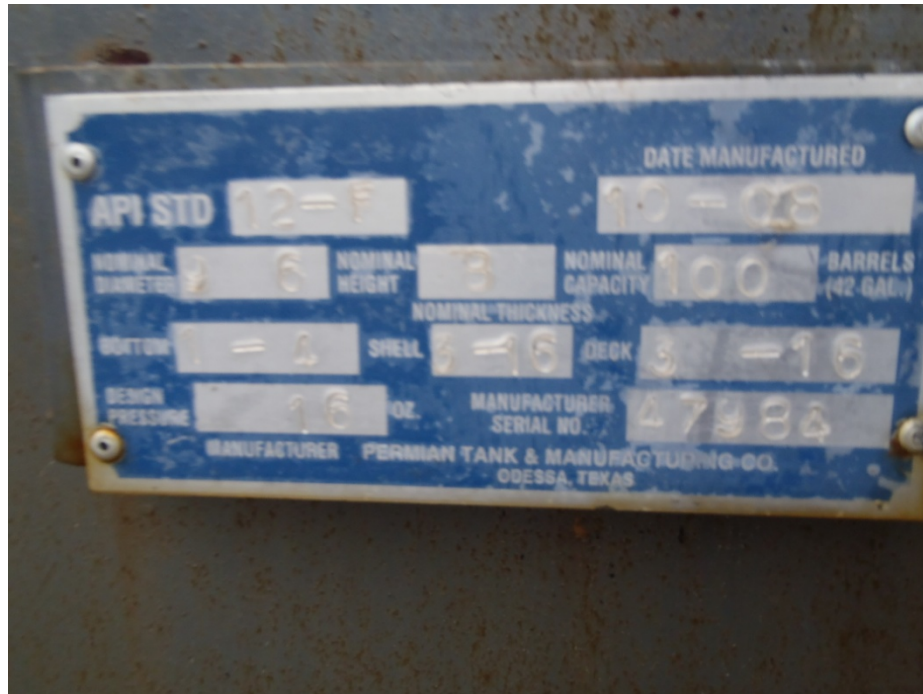
CLIENT: Williams Field Services	<i>DBI, Incorporated</i> 5330 N. 57th Street Lincoln, Nebraska 68507	
LOCATION: Stewart Dew Point Hickory. PA		
INSPECTION DATE: 7-19-2012	ACAD DWG. FILE: T-685	
TANK No: T-685	DWN BY: MCS	CKD BY:
TANK ID: Lube Oil/Drain Tank	MECHANICAL INTEGRITY INSPECTION

T-MIN.	T-MAX.	Remaining Life	Corrosion Rate
	(Recorded)	(Recorded)	(Years)	(Mils Per Year)
			(API 653 6.3.2)	(API 653 3.9)
			(API 575)	(API 575)
Shell Course No. 1	0.181	0.183	20+	<1 mil
Shell Course No. 2	0.181	0.182	20+	<1 mil
Roof	0.176	0.179	20+	<1 mil

UT measurements	<input checked="" type="checkbox"/>	<input type="checkbox"/>	<input type="checkbox"/>	See autocad drawing
